Prince George's County Planning Department  
of the  
Maryland-National Capital Park and Planning Commission

**Old Marlboro High School  
Historic Building Assessment and Treatment Plan**

**May 8, 2015**

**BELL Architects, PC**  
1228 9<sup>TH</sup> Street NW  
Washington DC 20001

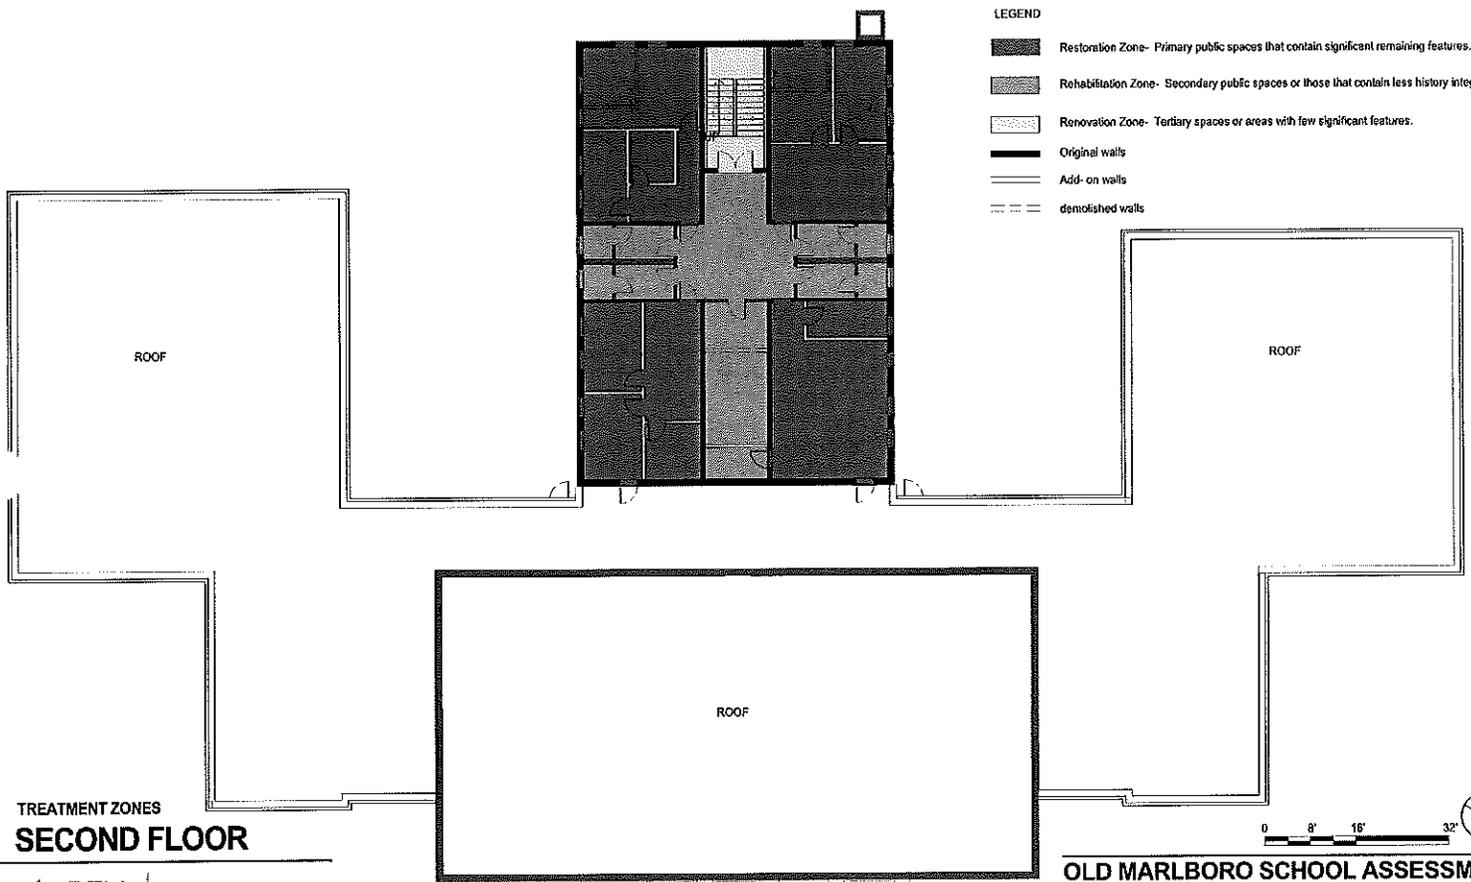
- Restoration Zone- Primary public spaces that contain significant remaining features.
- Rehabilitation Zone- Secondary public spaces or those that contain less history integrity.
- Renovation Zone- Tertiary spaces or areas with few significant features.
- Original walls
- Add-on walls
- demolished walls

See adjoining pages for floor plans diagramming the treatment zones.

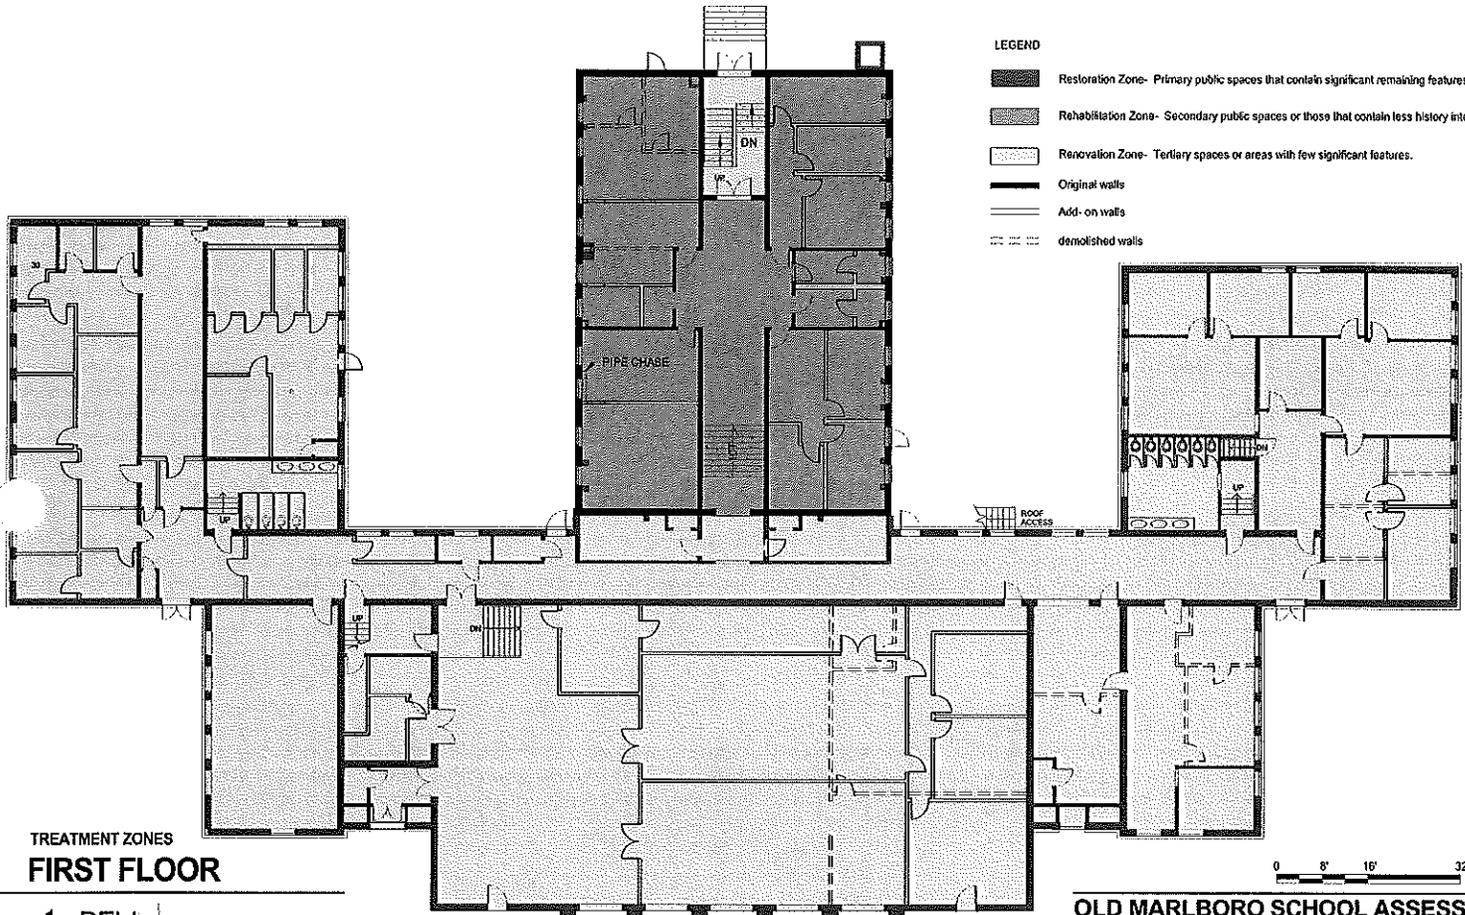
TREATMENT ZONES  
**FIRST FLOOR**

- LEGEND**
- Restoration Zone- Primary public spaces that contain significant remaining features.
  - Rehabilitation Zone- Secondary public spaces or those that contain less history integrity.
  - Renovation Zone- Tertiary spaces or areas with few significant features.
  - Original walls
  - Add-on walls
  - demolished walls

The classrooms on the first floor of the Old High School have less remaining historic fabric. Similar to the second floor the rooms have been altered. There is enough evidence in these spaces to be returned them to their original configuration. A similar amount of fabric is found in both the restroom and circulation spaces on both the first and second floors of the Old High School. All of these spaces are classified as rehabilitation zones.

The remainder of the spaces has little or no contributing fabric. The spaces in the 1934 addition have gone through several alterations and suffer from severe deterioration, so these spaces fall into the renovation zone.
